BELZONA REFURBISHES LOADING DOCK

ID: 6199

Customer Location: Business complex, Brisbane,
Queensland, Australia

Application: FPA-Floor Problem Areas

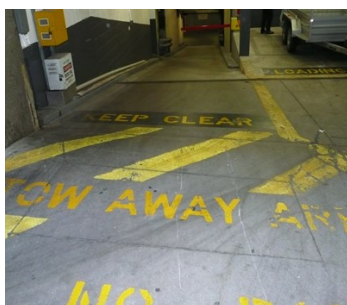
The Loading dock and car park were old and in need of a facelift as all of the original coating had been worn away.

* 1. The original condition of the floor area 2. Surface preparation in progress 3. A few small touch ups 4. The finished application showing the coated floor and reinstated lines, wording and chevrons ,
