BELZONA EXPANSION JOINT SEALANT FOR CORPORATE OFFICE

Customer Location: Corporate offices of Tennessee power company

Application: FPA-Floor Problem Areas

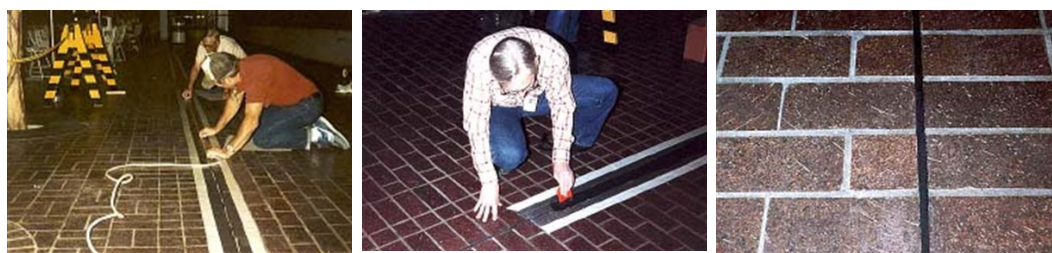
- * The application was carried out with the in-house maintenance staff of the power company. Closed cell foam backer rod being inserted. ,
- * Applying Belzona® 2221. ,
- * Expansion joint sealed. ,

The application was carried out in accordance with Belzona Know-How Leaflet FPA-6.

All expansion joints were sealed with approximately \$30,000 in Belzona product. Nearly ten years after, they are still in good shape.
