# BELZONA EXPANSION JOINT SEALANT FOR CORPORATE OFFICE

Customer Location: *Corporate offices of Tennessee power company*

Application: *FPA-Floor Problem Areas*

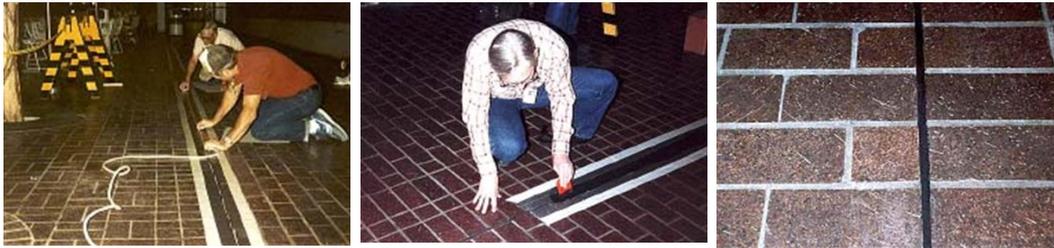
*Existing sealant breaking loose, creating a pedestrian safety hazard.*

- \* The application was carried out with the in-house maintenance staff of the power company. Closed cell foam backer rod being inserted. ,
- \* Applying Belzona® 2221. ,
- \* Expansion joint sealed. ,

The application was carried out in accordance with Belzona Know-How Leaflet FPA-6.

All expansion joints were sealed with approximately \$30,000 in Belzona product. Nearly ten years after, they are still in good shape.
