# NEW KERB CREATED WITH BELZONA

ID: 6204

Customer Location: shopping centre, Brisbane, Queensland, Australia

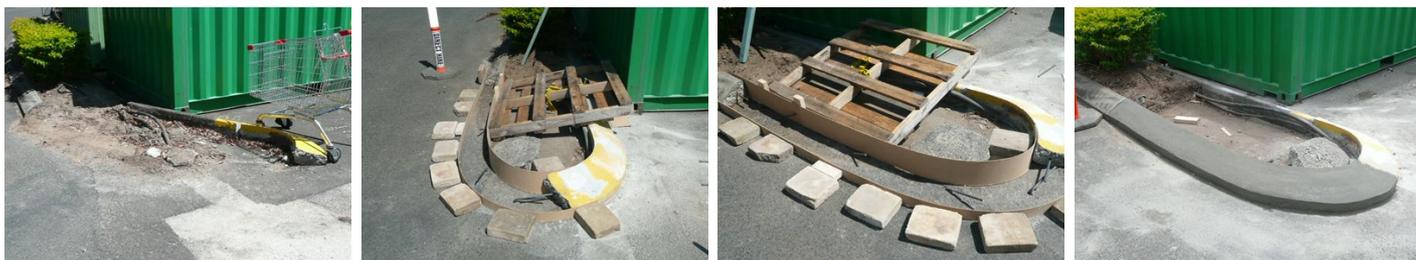
The existing kerb had been damaged and needed to be repaired / replaced

\* 1. The damaged missing nosings 2. Former being constructed 3. The former in position ready for repair to take place 4. The finished application, after removal of former, ready for painting ,

Application was carried out in accordance with a modified version of Belzona System Leaflet FPA-1. After removing damaged kerb an MDF former was installed and Belzona 4111 applied into the former to re-create the original kerb profile. Once Belzona 4111 had sufficiently cured, the former was removed leaving the perfectly formed kerb.
