NEW KERB CREATED WITH BELZONA

ID: 6204

Customer Location: shopping centre, Brisbane, Queensland, Australia

Application: FPA-Floor Problem Areas

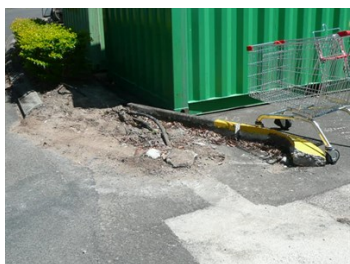
The existing kerb had been damaged and needed to be repaired / replaced

* 1. The damaged missing nosings 2. Former being constructed 3. The former in position ready for repair to take place 4. The finished application, after removal of former, ready for painting ,

Application was carried out in accordance with a modified version of Belzona System Leaflet FPA-1. After removing damaged kerb an MDF former was installed and Belzona 4111 applied into the former to re-create the original kerb profile. Once Belzona 4111 had sufficiently cured, the former was removed leaving the perfectly formed kerb.
