CURING CONCRETE CANCER WITH BELZONA

ID: 6206

Customer Location: Apartment Complex, Gold Coast, Australia

Application: WPA-Wall Problem Areas

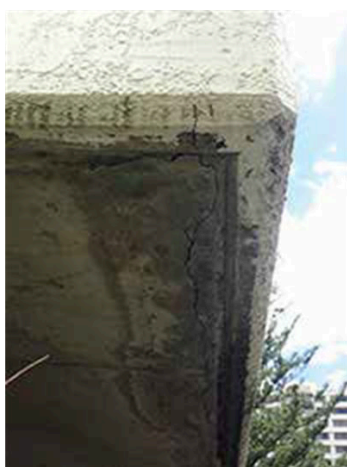
The original concrete was starting to degrade due to a combination of its prominent coastal location and incorrect positioning of the steel reinforcement during original construction. Carbonation had taken place causing corrosion of the reinforcement steel leading to concrete spalling.

* 1. Close up of the damaged balcony 2. Preparation underway 3. Application completed with temporary shuttering in place 4. The restored balcony ,
