CURING CONCRETE CANCER WITH BELZONA

Customer Location: Apartment Complex, Gold Coast, Australia

Application: WPA-Wall Problem Areas

Concrete balcony at a residential apartment complex

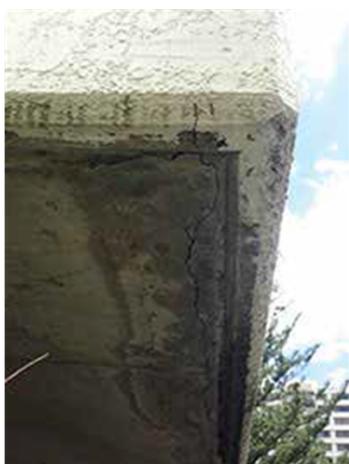
The original concrete was starting to degrade due to a combination of its prominent coastal location and incorrect positioning of the steel reinforcement during original construction. Carbonation had taken place causing corrosion of the reinforcement steel leading to concrete spalling.

* 1. Close up of the damaged balcony 2. Preparation underway 3. Application completed with temporary shuttering in place 4. The restored balcony ,
