BELZONA WATERPROOFS HIGH RISE BUILDING

ID: 6207

Application: RPA-Roof Problem Areas

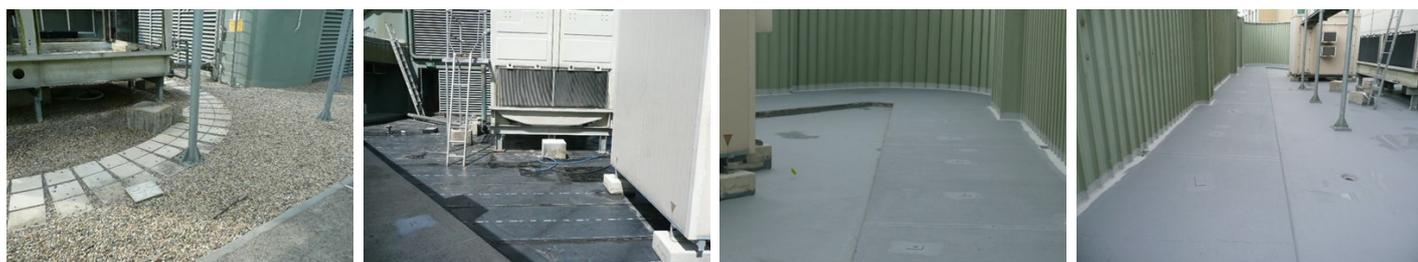
Photograph Descriptions

The existing roofing system had failed allowing water to leak into the offices below.

- * 1. The roof before application showing the stone covering ,
- * 2. Roof stripped and ready to coat ,
- * 3. 1st coat of reinforced Belzona 3111 applied ,
- * 4. The finished application ,

Application was carried out in accordance with Belzona System Leaflet RPA-1. Before application could commence the decorative stones had to be removed. Further inspection revealed that the existing roof membrane had perished and the decision was made to reseal the entire roof including the concrete walkways. The roof was stripped and cleaned before being over-coated with a fully reinforced Belzona 3111 system.
