BELZONA REPAIRS CAR PARK RAMP

ID: 6210

Customer Location: Shopping centre, Bankstown, Australia
Application Date: March 2004

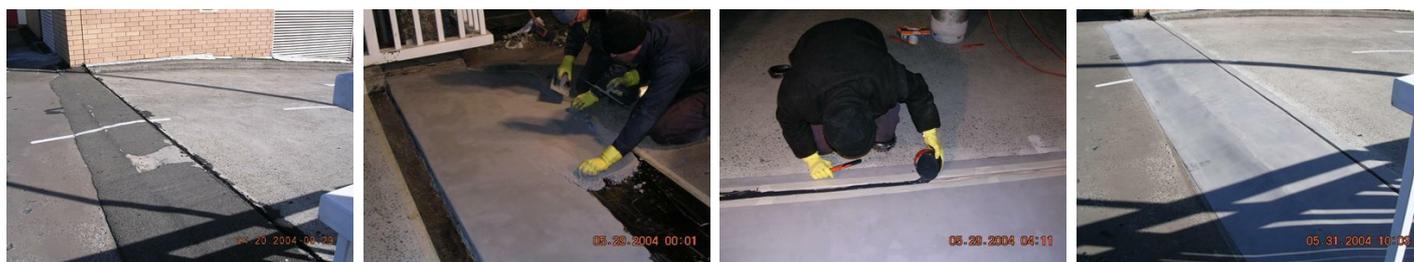
Photograph Descriptions

Existing ramp concrete surface was badly damaged and expansion joint between the concrete slabs had deteriorated.

- * 1. The damaged ramp ,
- * ,
- * 2. Applying Belzona 4111 to the ramp ,
- * ,
- * 3. Pouring Belzona 2221 to seal the expansion joint ,
- * ,
- * 4. The completed ramp and expansion joint ,

Application was carried out in accordance with the Belzona Know-How System leaflets FPA-1 and FPA-6. Existing ramp was removed by jackhammering and grinding and replaced with Belzona 4111. Existing expansion joint seal was removed and replaced with Belzona 2221 Elastomer.

High strength, impact resistant Belzona 4111 allowed ramp to be quickly and effectively restored. Belzona 2221 forms a highly elastic seal between the slabs.
