BELZONA REPAIRS CAR PARK RAMP

ID: 6210

Customer Location: Shopping centre, Bankstown, Australia
Application Date: March 2004

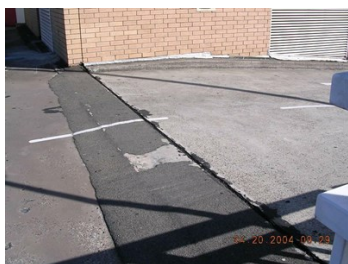
Existing ramp concrete surface was badly damaged and expansion joint between the concrete slabs had deteriorated.

- * 1. The damaged ramp ,
- * ,
- * 2. Applying Belzona 4111 to the ramp ,
- * ,
- * 3. Pouring Belzona 2221 to seal the expansion joint ,
- * ,
- * 4. The completed ramp and expansion joint ,

Application was carried out in accordance with the Belzona Know-How System leaflets FPA-1 and FPA-6. Existing ramp was removed by jackhammering and grinding and replaced with Belzona 4111. Existing expansion joint seal was removed and replaced with Belzona 2221 Elastomer.
