BELZONA REPAIRS SHOPPING CENTRE EXPANSION JOINT

Customer Location: Shopping centre, Campbelltown, Australia

Application: FPA-Floor Problem Areas

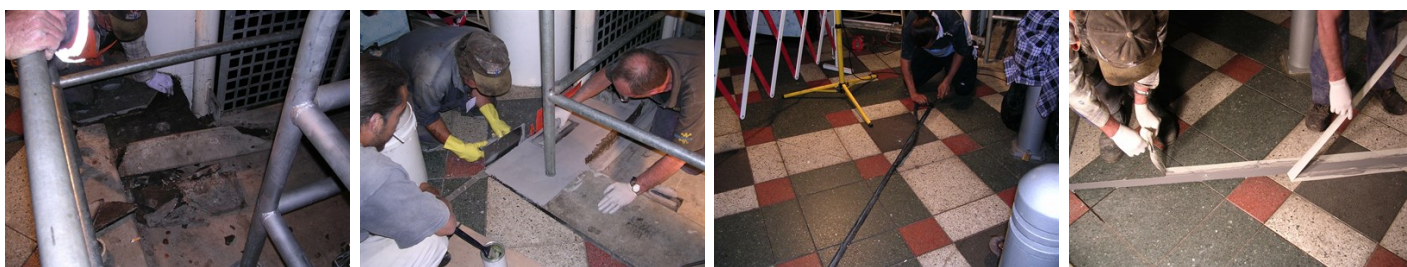
Photograph Descriptions

The concrete floor and joint nosings were badly damaged and the expansion joint was disbonding from the edges allowing water to leak to the lower level. As joint was in the main entrance to the shopping centre, it presented a serious trip hazard.

- * 1. The damaged concrete ,
- * ,
- * 2, Rebuilding the damaged concrete with Belzona 4111 ,
- * ,
- * 3. Removing the damaged expansion joint ,
- * ,
- * 4. The new expansion joint created with Belzona 4521 ,

Application was carried out in accordance with Belzona Know-How System Leaflets FPA-1 & FPA 6. The damaged concrete was ground out and replaced with Belzona 4111 then the existing expansion joint was replaced by pouring in Belzona 4521.
