BELZONA PROTECTS PLATE HEAT EXCHANGER COVERS

ID: 624

Customer Location: South African Refinery
Application Date: Various since 1994

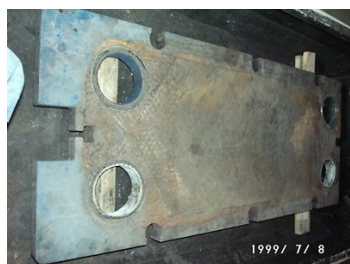
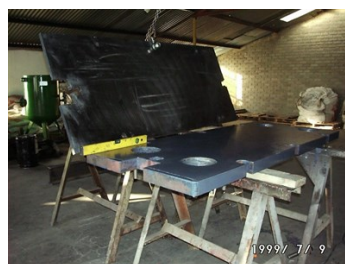
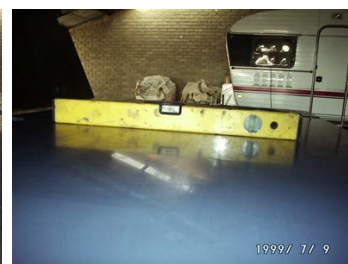
Photograph Descriptions

Galvanic and crevice corrosion to the end covers of the heat exchangers was resulting in leaking around the titanium plates and loss of efficiency.

- * Previously corroded cover ,
- * Former clamped into position ,
- * Post application inspection ,
- * Perfectly smooth finish ,

Using a modified version of Belzona Know-How System Leaflet GSS-9, a plate is coated with Belzona® 9411 and used to form a thick layer of Belzona 1341 on the end cover. This procedure provides a perfect finish and excellent seal.
