BELZONA REPAIRS AT LOCAL SCHOOL

Customer Location: *High School - Grant County, West Virginia U.S.A.*

Erosion-corrosion on a 6,000 gallon water tank clarifier

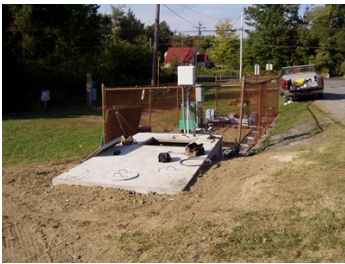
Deterioration of steel due to daily contact with chlorine.

- * Overview of the working area ,
- * Repairs in progress accelerating the cure time ,
- * Completed repairs ,

Application was carried out in accordance with Belzona System leaflet TCC-1.

Welding in this instance would have been costly and time consuming due to the limited space and working in over 6 feet of water, Belzona® 1111 was therefore used. The Belzona solution was completed in two hours as compared to a whole day with a traditional repair approach and the school stayed open during this entire time.
