Belzona repairs swimming pool

Application: FPA-Floor Problem Areas

Customer Location: Kwidzyn (Poland)

Application Date: May 2011

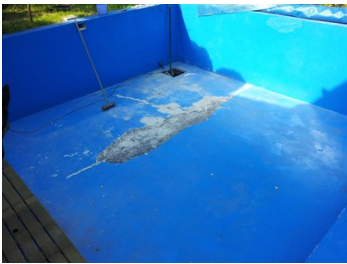
A significant water leak from the pool due to the crack of the concrete.

- * 1. General view of the damaged bases ,
- * 2. The bottom of the pool after the application of Belzona 4151 ,
- * 3. Supplementing concrete damage - Belzona 4111. ,
- * 4.General view of the swimming pool. ,

Concrete crack on the bottom of the swimming pool .

Previous repairs to other materials did not cause inhibition of the leak. Removed loose and wet concrete parts. The entire exposed concrete was painted Belzona4151. At the end of applied Belzona 4111.
