BELZONA CURES DRUG FACTORY FLOOR

Customer Location: Pharmaceutical company, Warsaw, Poland

Application: FPA-Floor Problem Areas

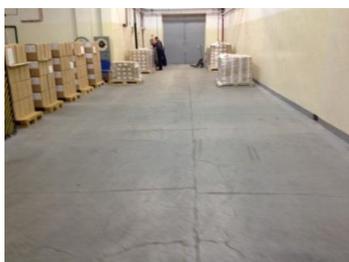
* 1. View of damaged warehouse floor 2. Close up of the cracked concrete 3.and 4. The floor after application of Belzona 5811 ,

Very damaged and cracked concrete floor in the medicines factory.

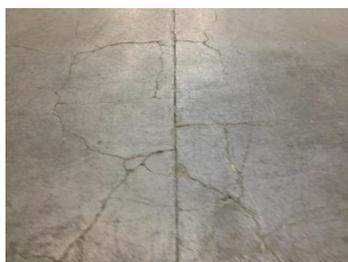
The cracks collect a lot of bacteria and contaminants creating a serious hygiene issue.
