BELZONA LEVELS TAXI STAND

ID: 6256

Customer Location: Shopping centre, Brisbane, Queensland, Australia

Application: FPA-Floor Problem Areas

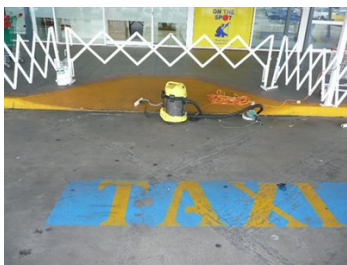
The concrete slab, adjacent to the ramp for the taxi stand, had sunk and created a step that had become a trip hazard. This had also made wheelchair access difficult.

- * 1. The taxi stand ramp ,
- * 2. Close up showing the step between the ramp and road with surface preparation underway ,
- * 3. The finished application ,
- * 4. Three years on and still in perfect condition ,

This application was carried out in accordance with Belzona System Leaflet FPA-1. Belzona 4111 was used to re-profile the ramp creating a smooth transition from the road onto the footpath.

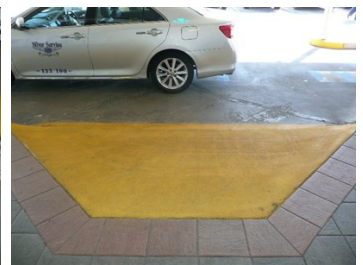
Belzona 4000 series materials are the product of choice for this busy shopping centre because they allow repairs to be carried out quickly and easily with minimum disruption and at the same time provide long term, permanent repairs. Even after 3 years of constant use , the ramp is still performing well with no signs of deterioration or cracking
