PUMP REPAIR AND EFFICIENCY ENHANCEMENT WITH BELZONA

ID: 626

Application: *CEP-Centrifugal Pumps*

Customer Location: *Drinking Water Supplier, Portugal*

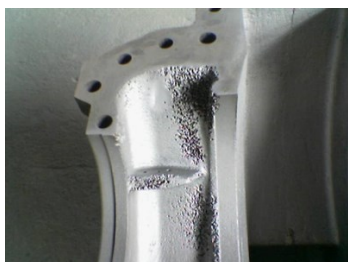
The pump had significant corrosion.

- * The severe localised corrosion ,
- * Application of Belzona® 1111 ,
- * The completed repair ,
