# PUMP REPAIR AND EFFICIENCY ENHANCEMENT WITH BELZONA

ID: 626

**Customer Location:** Drinking Water Supplier, Portugal  
**Application Date:** February 2004

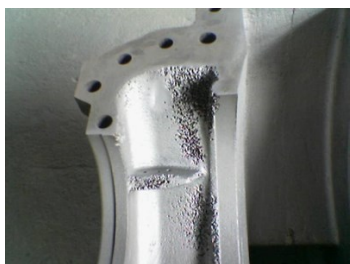
The pump had significant corrosion.

- \* The severe localised corrosion ,
- \* Application of Belzona® 1111 ,
- \* The completed repair ,
