END SUCTION PUMP REPAIRS WITH BELZONA

ID: 627

Customer Location: *Sugar beet plant, Portugal*

Several large end suction pumps used in processing of sugar beet.

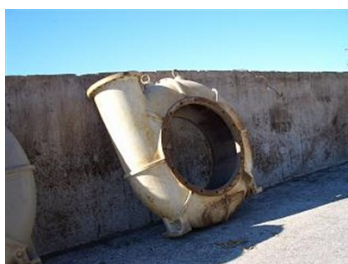
The pumps had suffered severe erosion and significant corrosion caused by solids entrainment.

- * Pump housing ,
- * End covers with erosion clearly evident ,
- * The components restored to original dimensions ,

Application was carried out in accordance with Belzona Know-How System Leaflet SHM-11.
