# BELZONA ROOF REPAIRS AT PROMINENT RETAILER

Industry: Commercial Facilities  
Application: RPA-Roof Problem Areas  
Substrate: Concrete  
Products: \* Belzona 3111 (Flexible Membrane) ,

Customer Location: Department store, NSW, Sydney  
Application Date: December 2004

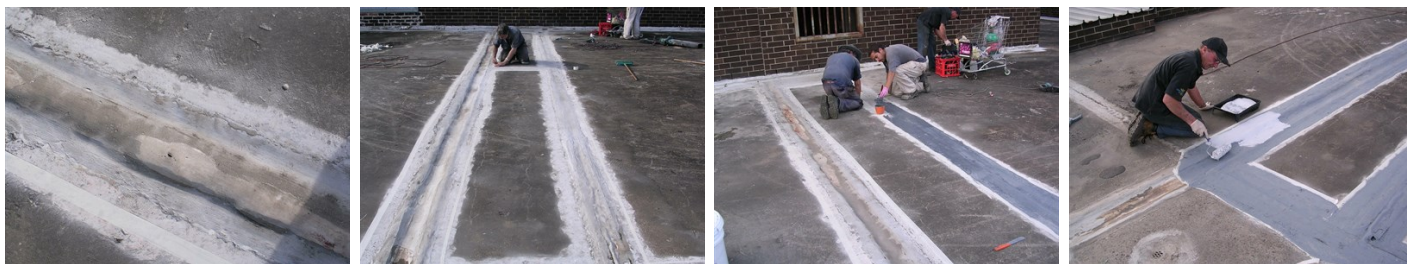
*Leaking joints were causing disruption to staff and shoppers at this high end department store.*

\* 1. The leaking joints 2. Masking off before starting application 3. Conditioned joints 4. Application of Belzona 3111 in progress ,

Application was carried out in accordance with Belzona System Leaflet RPA-1. A fully reinforced Belzona 3111 system was applied to span across the joints.

Belzona 3111 was chosen because it only needed to be applied at the problem joints so making application quick and simple.
