BELZONA ROOF REPAIRS AT PROMINENT RETAILER

Industry: *Commercial Facilities*
Application: *RPA-Roof Problem Areas*
Substrate: *Concrete*
Products: ** Belzona 3111 (Flexible Membrane) ,*

Customer Location: *Department store, NSW, Sydney*
Application Date: *December 2004*

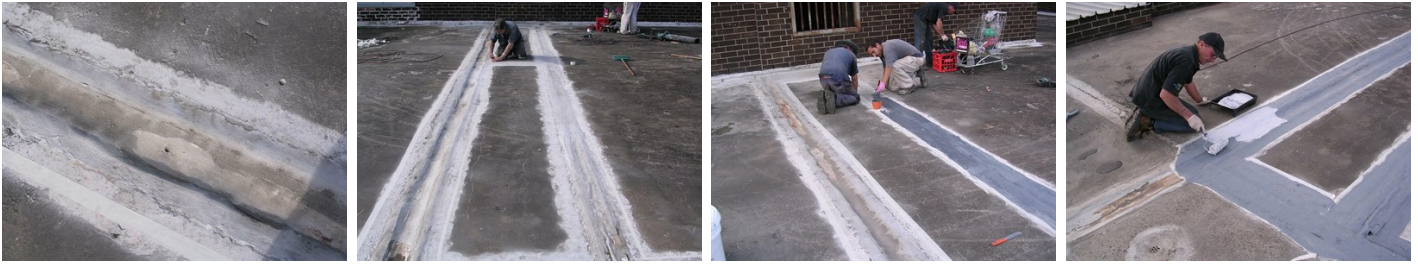
Photograph Descriptions

Leaking joints were causing disruption to staff and shoppers at this high end department store.

* 1. The leaking joints 2. Masking off before starting application 3. Conditioned joints 4. Application of Belzona 3111 in progress ,

Application was carried out in accordance with Belzona System Leaflet RPA-1. A fully reinforced Belzona 3111 system was applied to span across the joints.

Belzona 3111 was chosen because it only needed to be applied at the problem joints so making application quick and simple.
