BELZONA SEALS PARAPET WALL

ID: 6276

Customer Location: Shopping Centre, NSW, Australia
Application Date: July 2004

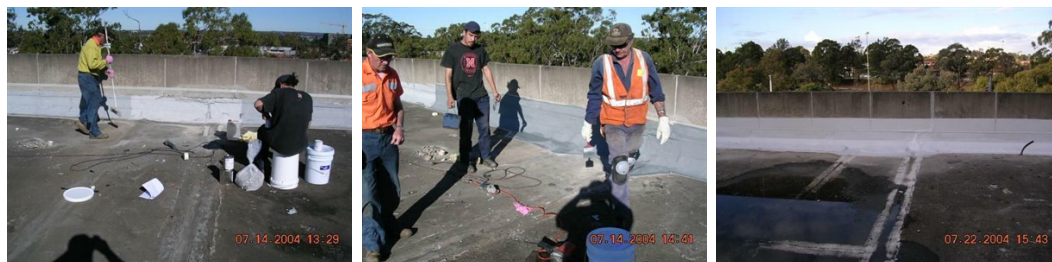
Photograph Descriptions

Ingress of water into the building below caused by failed sealant on the parapet wall joints.

* 1. Preparation in progress 2. Surface Conditioner applied 3. completed application ,

Application was carried out in accordance with Belzona System Leaflet RPA-8. A fully reinforced Belzona 3111 system was applied to bridge between roof deck and wall.

Belzona 3111 was used for its easy application and ability to seal multiple substrates whilst coping with the differential movement present at the flashing.
