# BELZONA RENEWS EXPANSION JOINT AT SHOPPING CENTRE

**Industry:** Buildings & Structures  
**Application:** FPA-Floor Problem Areas  
**Substrate:** Concrete  
**Products:** \* Belzona 4111 (Magma Quartz),  
\* Belzona 2221 (MP Fluid Elastomer),

**Customer Location:** Shopping Centre, NSW, Australia  
**Application Date:** April 2004

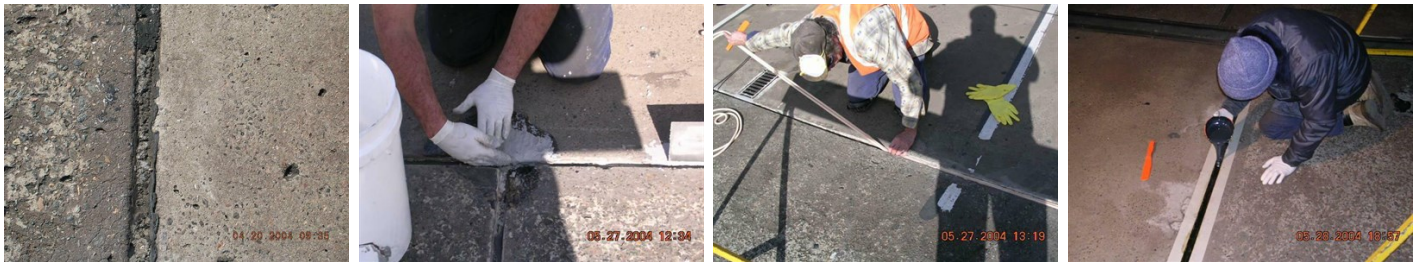
The existing joint material had failed resulting in a route for water to leak to the building below and was also creating a trip hazard.

- \* 1. The failed joint ,
- \* 2. Rebuilding with Belzona 4111 ,
- \* 3. Packing the joint with backer rod ,
- \* 4. Pouring the Belzona 2221 Elastomer to finish the job ,

Application was carried out in accordance with Belzona System Leaflets FPA-5 and FPA-6. The existing joint material was removed and the edges of the joint rebuilt using Belzona 4111. Once this had cured sufficiently, the joint was conditioned using Belzona 2911 (QD Conditioner) before Belzona 2221 was poured to seal the joint.
