A NEW BELZONA EXPANSION JOINT FOR NEWSROOM

ID: 6278

Customer Location: Newsprint Company, NSW, Australia
Application Date: December 2004

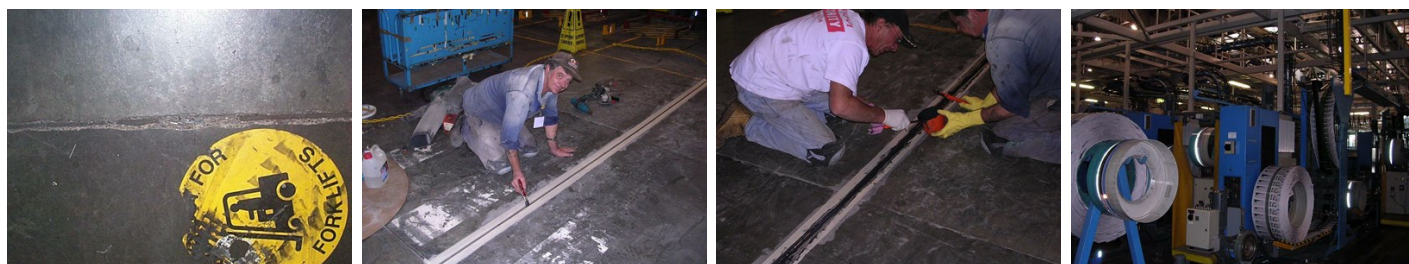
Photograph Descriptions

The existing joint and adjoining concrete slab had been damaged by constant fork truck traffic. This was now becoming a Health & Safety issue.

- * 1. The existing joint with warning signs attached ,
- * 2. Joint masked off and Conditioner being applied ,
- * 3. The Belzona 2221 being poured ,
- * 4. The newsprint production equipment ,

The application was carried out in accordance with Belzona System Leaflets FPA-5 and FPA-6. The existing joint material was removed and the concrete slab edges rebuilt back to square using the Belzona 4111 before pouring the Belzona 2221 system to seal the joint.
