# A NEW BELZONA EXPANSION JOINT FOR NEWSROOM

ID: 6278

**Customer Location:** Newsprint Company, NSW, Australia  
**Application Date:** December 2004

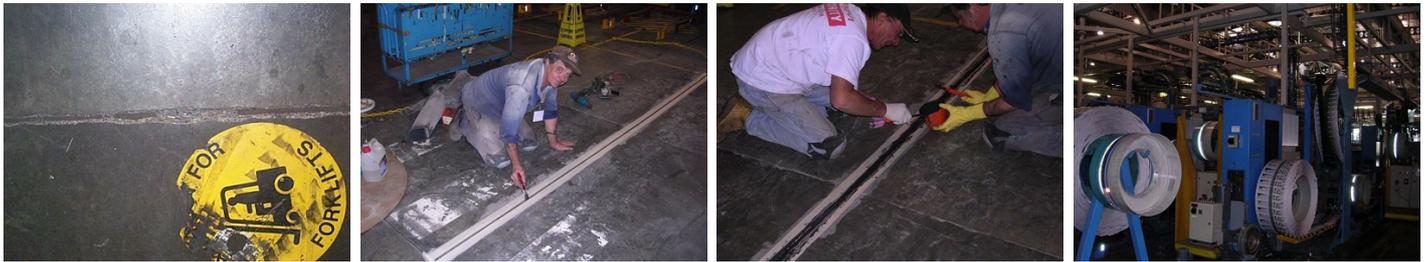
## Photograph Descriptions

The existing joint and adjoining concrete slab had been damaged by constant fork truck traffic. This was now becoming a Health & Safety issue.

- \* 1. The existing joint with warning signs attached ,
- \* 2. Joint masked off and Conditioner being applied ,
- \* 3. The Belzona 2221 being poured ,
- \* 4. The newsprint production equipment ,

The application was carried out in accordance with Belzona System Leaflets FPA-5 and FPA-6. The existing joint material was removed and the concrete slab edges rebuilt back to square using the Belzona 4111 before pouring the Belzona 2221 system to seal the joint.
