NEW BELZONA FLOOR FOR NEW SHOWROOM

Industry: Commercial Facilities
Application: FPA-Floor Problem Areas
Substrate: Concrete
Products: * Belzona 5231 (SG Laminate) ,

Customer Location: Car showroom, Nowra, NSW, Australia
Application Date: January 2005

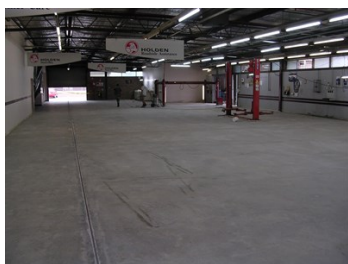
- * 1. Floor prior to coating ,
- * 2. Preparation complete, vacuuming up the dust ,
- * 3. Application underway ,
- * 4. Application complete and being inspected by the client ,

The application was carried out in accordance with Belzona System Leaflet FPA-3. The newly laid floor was allowed to dry out thoroughly before being prepared for coating by diamond grinding to remove surface laitence. After vacuuming to remove dust, the floor was coated with two coats of Belzona 5231.
