NEW BELZONA FLOOR FOR NEW SHOWROOM

ID: 6280

Customer Location: Car showroom, Nowra, NSW, Australia
Application Date: January 2005

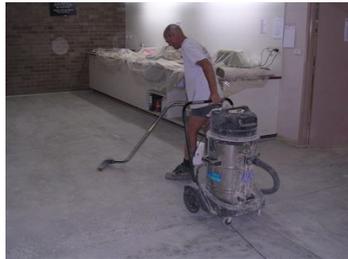
- * 1. Floor prior to coating ,
- * 2. Preparation complete, vacuuming up the dust ,
- * 3. Application underway ,
- * 4. Application complete and being inspected by the client ,

The application was carried out in accordance with Belzona System Leaflet FPA-3. The newly laid floor was allowed to dry out thoroughly before being prepared for coating by diamond grinding to remove surface laitence. After vacuuming to remove dust, the floor was coated with two coats of Belzona 5231.
