BELZONA REFURBISHED LOADING DOCK STILL GOOD 7 YEARS ON

ID: 6281

Customer Location: Business complex, Brisbane,
Queensland, Australia

Application: FPA-Floor Problem Areas

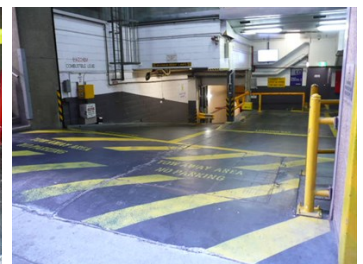
* 1. The original condition of the floor area 2. Surface preparation in progress 3. The finished application showing the coated floor and reinstated lines, wording and chevrons 4. The floor after 7 years in service ,

Belzona materials were chosen due to their ease of application, proven longevity and incorporated grip system that provides a safer and more durable finish than conventional floor paints. This decision has proven to be the right one as the floor is still in a serviceable condition 7 years later
