# BELZONA REFURBISHED LOADING DOCK STILL GOOD 7 YEARS ON

ID: 6281

Application: FPA-Floor Problem Areas

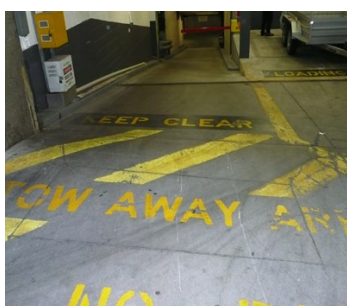
The Loading dock and car park were old and in need of a facelift as all of the original coating had been worn away.

\* 1. The original condition of the floor area 2. Surface preparation in progress 3. The finished application showing the coated floor and reinstated lines, wording and chevrons 4. The floor after 7 years in service ,

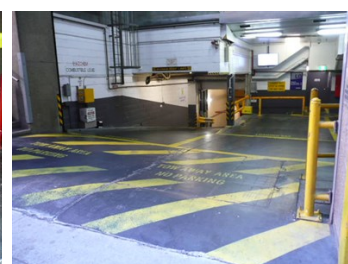
Belzona materials were chosen due to their ease of application, proven longevity and incorporated grip system that provides a safer and more durable finish than conventional floor paints. This decision has proven to be the right one as the floor is still in a serviceable condition 7 years later
