BELZONA RESURFACES WATER SUPPLY TROUGH AT OUTDOOR SWIMMING POOL

ID: 6287

Industry: *Buildings & Structures*
Application: *FPA-Floor Problem Areas*
Substrate: *Concrete*
Products: ** Belzona 4111 (Magma-Quartz) ,*

Customer Location: *Coquitlam, BC*
Application Date: *April 2015*

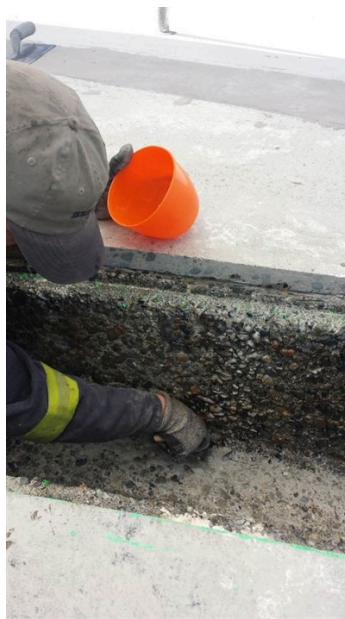
Over period of many years, the pool chemicals had attacked the concrete channel leaving the aggregate exposed. Ultimately loose aggregate would get into the pumps and damage them.

- * 1. View of water supply channel ,
- * 2. View of the eroded surface that needs to be resurfaced ,
- * 3. Resurfacing with Belzona 4111 in progress. ,
- * 4. Completed supply channel ,
