BELZONA RESURFACES WATER SUPPLY TROUGH AT OUTDOOR SWIMMING POOL

ID: 6287

Customer Location: *Coquitlam, BC*
Application Date: *April 2015*

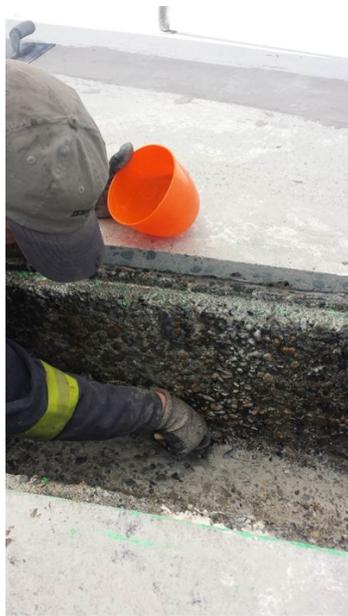
Over period of many years, the pool chemicals had attacked the concrete channel leaving the aggregate exposed. Ultimately loose aggregate would get into the pumps and damage them.

- * 1. View of water supply channel ,
- * 2. View of the eroded surface that need to be resurfaced ,
- * 3. Resurfacing with Belzona 4111 in progress. ,
- * 4. Completed supply channel ,
