# BELZONA SEALS LEAK IN UNDERWATER OBSERVATION WINDOW

Industry: *Buildings & Structures*  
Application: *FPA-Floor Problem Areas*  
Substrate: *Stainless Steel/ Butyl Rubber*  
Products: *\* Belzona 2211 (MP Hi-Build Elastomer) ,*

Customer Location: *Vancouver, BC*  
Application Date: *March 2015*

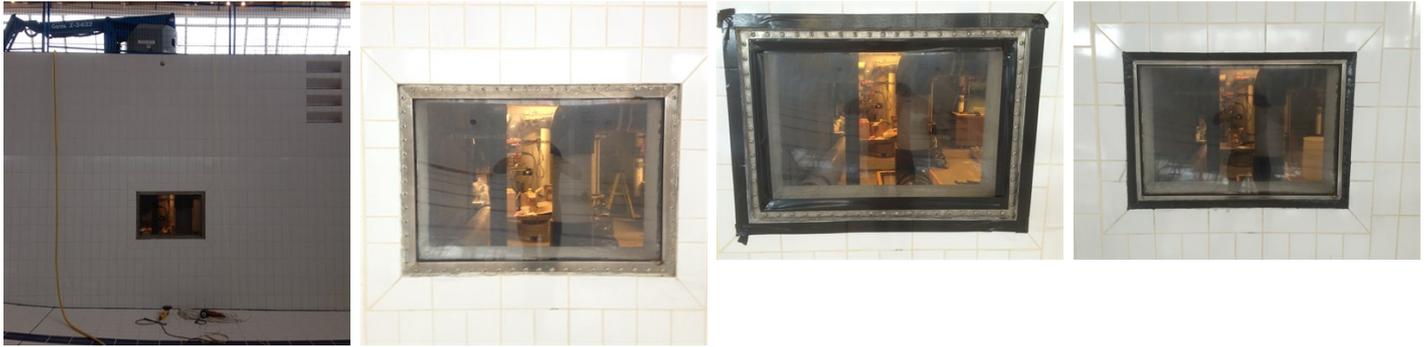
## Photograph Descriptions

*The underwater observation window had developed a leak.*

- \* 1. View of observation window ,
- \* 2. Metal surface prepared ,
- \* 3. Perimeter of the window masked off ,
- \* 4. Completed application with all tapes removed ,

The application was carried out in accordance with a modified Belzona Know-How System Leaflet FPA-6. The stainless steel surround was prepared using a grinder to achieve a clean rough profile on the metal surface. After masking off the perimeter, a 1/8" thick rubber tape was used to create a suitable clearance on the inside of the window-sufficient to clear the screw heads.
