# PROTECTING ENGINE BLOCK WITH BELZONA

Industry: *Marine*  
 Application: *ENC-Engines and Casings*  
 Substrate: *Cast iron*  
 Products: *\* Belzona® 1111 (Super Metal) ,*  
*\* Belzona® 1391 (Ceramic HT) ,*

Customer Location: *Dry docks, Oporto, Portugal*  
 Application Date: *March 2005*

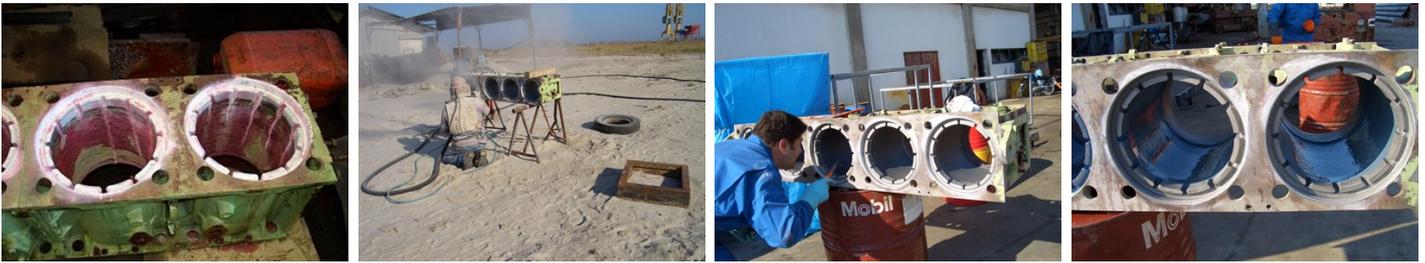
*Corrosion in water jacket around cylinder liners.*

- \* Corroded block with liners removed ,
- \* Surface preparation by grit blasting ,
- \* Application of Belzona ,
- \* Finished application ,

Application was carried out in accordance with Belzona Know-How System Leaflet ENC-6. Belzona® 1111 used to restore profiles before coating with Belzona® 1391 to provide long term erosion corrosion.
