BELZONA SEALS HIGH 270° CIRCULAR PARAPET WALL

ID: 6290

Customer Location: Coquitlam, BC

Application: RPA-Roof Problem Areas

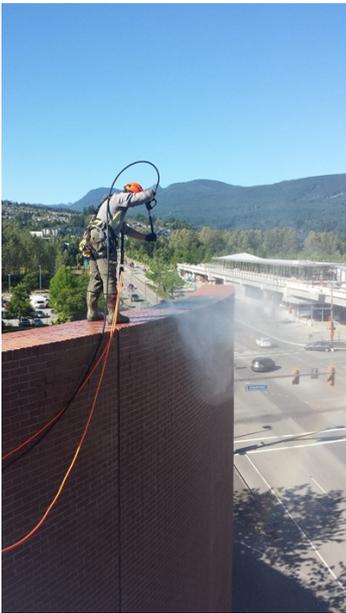
- * 1.View of wall being pressure washed prior to application. It was established at this point that the bricks may have been sealed at some points creating a possible adhesion problem. ,
- * 2.The brick surface being ground to ensure adequate adhesion ,
- * 3.Application of Belzona 3911 ,
- * 4. Application of 1st coat of Belzona 3111 completed. ,
