# Belzona replaces indoor swimming pool expansion joints

ID: 6292

Industry: *Buildings & Structures*  
Application: *FPA-Floor Problem Areas*  
Substrate: *Concrete/ Tile*  
Products: *\* Belzona 2221 (MP Fluid Elastomer) ,*

Customer Location: *Tsawwassen, BC*  
Application Date: *August 2015*

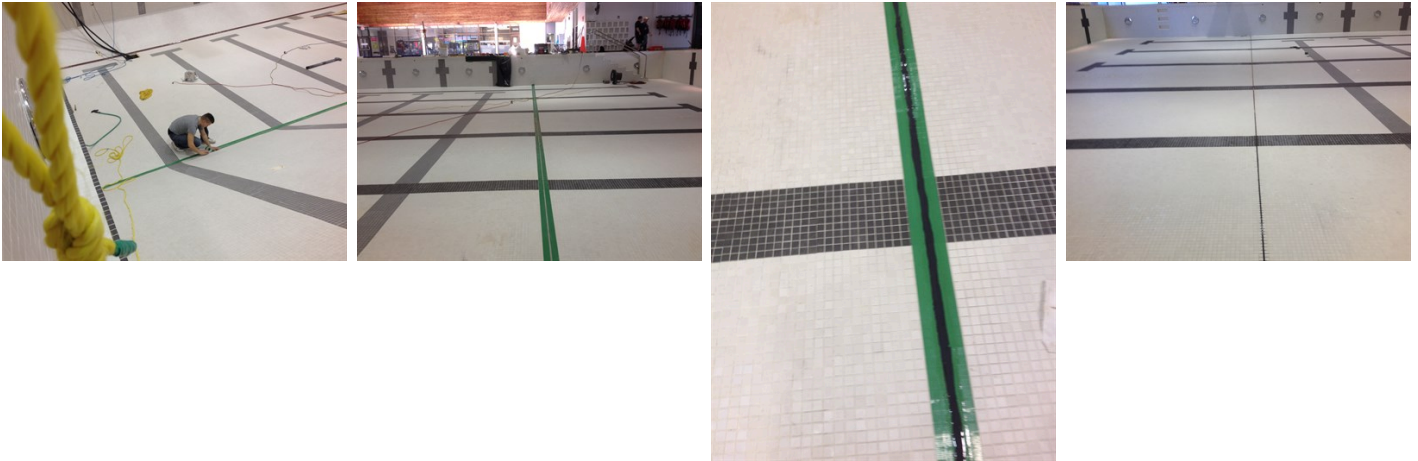
## Photograph Descriptions

*Existing expansion joint material had failed.*

- \* 1. Joint preparation completed by grinding the expansion joint slot to a clean dry porous finish ,
- \* 2. Joint masked off to ensure a neat and tidy finish ,
- \* 3. Application of Belzona 2221 ,
- \* 4. Completed application. ,

The application was carried out in accordance with Belzona Know-How System Leaflet FPA-6. The surface was grinded to a clean dry porous finish, then Belzona 2221 was injected into the joint and allowed to settle and cure.
