Belzona replaces indoor swimming pool expansion joints

ID: 6292

Customer Location: *Tsawwassen, BC*
Application Date: *August 2015*

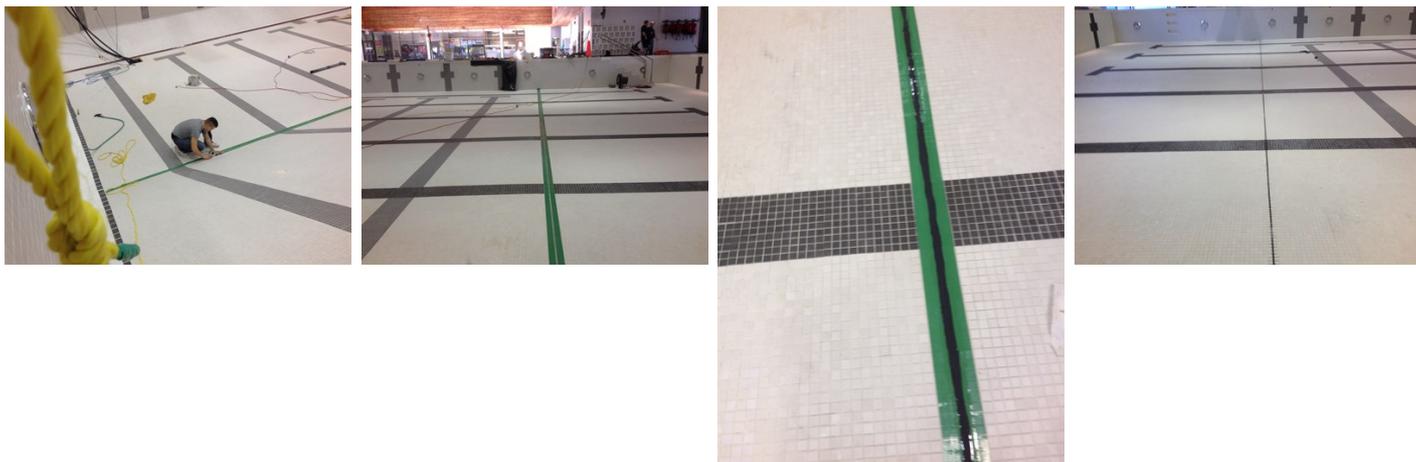
Photograph Descriptions

Existing expansion joint material had failed.

- * 1. Joint preparation completed by grinding the expansion joint slot to a clean dry porous finish ,
- * 2. Joint masked off to ensure a neat and tidy finish ,
- * 3. Application of Belzona 2221 ,
- * 4. Completed application. ,

The application was carried out in accordance with Belzona Know-How System Leaflet FPA-6. The surface was grinded to a clean dry porous finish, then Belzona 2221 was injected into the joint and allowed to settle and cure.

This was the 3rd Belzona Elastomer expansion joint application. The original application completed in 2007 which it lasted for more than 8 years before it required any further maintenance.
