BELZONA REPAIRED CAR PARK JOINT STILL INTACT

ID: 6294

Customer Location: Shopping Centre, Brisbane, Australia
Application Date: June 2013

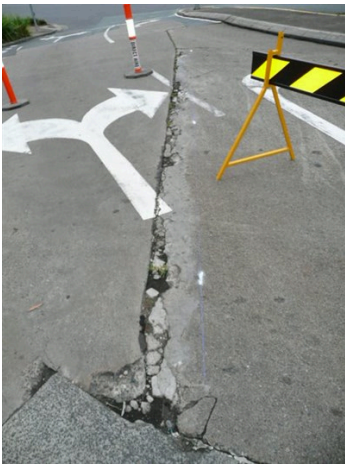
The edge nosings of the concrete slabs had been broken down to rubble after years of daily traffic making them unsightly and dangerous

- * 1. The damaged floor joint ,
- * 2. Conditioned and ready for repair ,
- * 3. Repairs in progress ,
- * 4. Repaired joint 3 years after completion ,

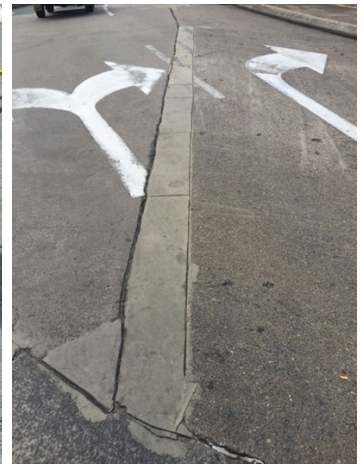
Belzona 4111 was used for its high strength, fast curing and ease of application. The floor repair is still in good condition more than

3 years later.
