BELZONA REPAIRED CAR PARK JOINT STILL INTACT

ID: 6294

Customer Location: *Shopping Centre, Brisbane, Australia*
 Application Date: *June 2013*

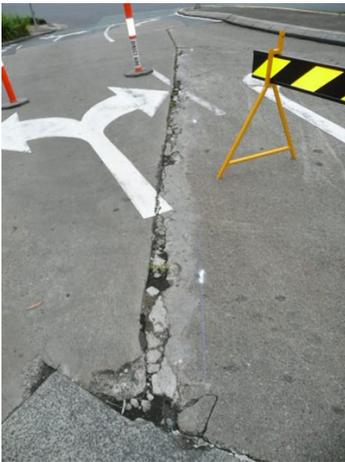
The edge nosings of the concrete slabs had been broken down to rubble after years of daily traffic making them unsightly and dangerous

- * 1. The damaged floor joint ,
- * 2. Conditioned and ready for repair ,
- * 3. Repairs in progress ,
- * 4. Repaired joint 3 years after completion ,

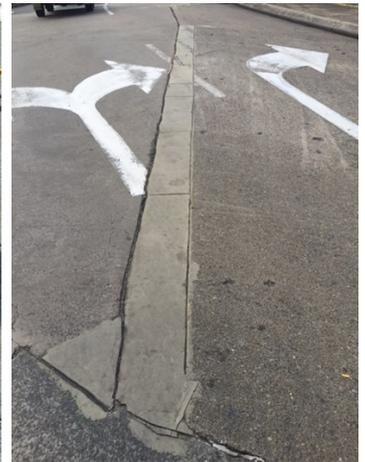
Belzona 4111 was used for its high strength, fast curing and ease of application. The floor repair is still in good condition more than

3 years later.
