# BELZONA PROTECTS ACID BUND AT CHEMICAL PLANT

**Customer Location:** Chemical plant, Kwinana, Western Australia

**Application:** TCC-Tanks and Chemical Containment Areas

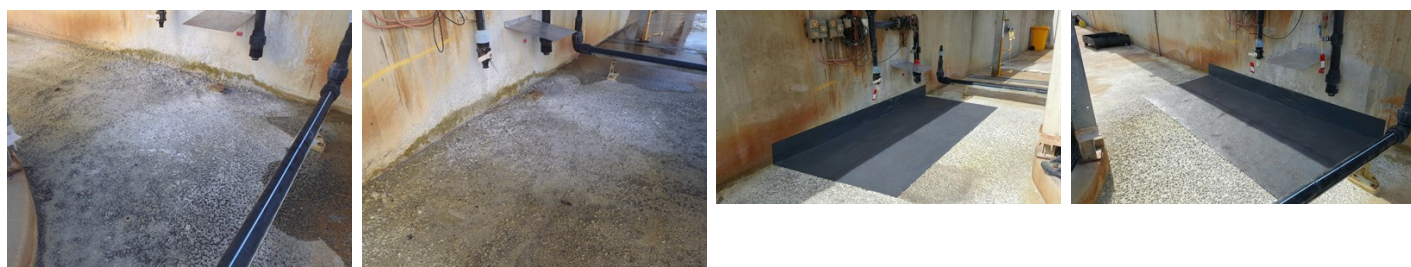
The concrete floor of the bund had been damaged by leaks during tanker deliveries.

- \* 1. Original condition of concrete before repair ,
- \* 2. Another view of the damage ,
- \* 3. Completed application ,
- \* 4. Another view of the completed application ,

Application was carried out in accordance with Belzona System Leaflet TCC-15. The floor of the bund was first washed to neutralise any remaining acid contamination before being abrasive blasted. Belzona 4111 used to rebuild damaged concrete before applying two coat system of Belzona 4311. Aggregate was applied to top surface whilst wet to create a non-slip surface.
