80 TONNE BULLDOZER TRACKS-NO PROBLEM FOR BELZONA

Customer Location: Workshop floor, Kwinana, Western Australia

Application: FPA-Floor Problem Areas

Substrate: Reinforced Concrete

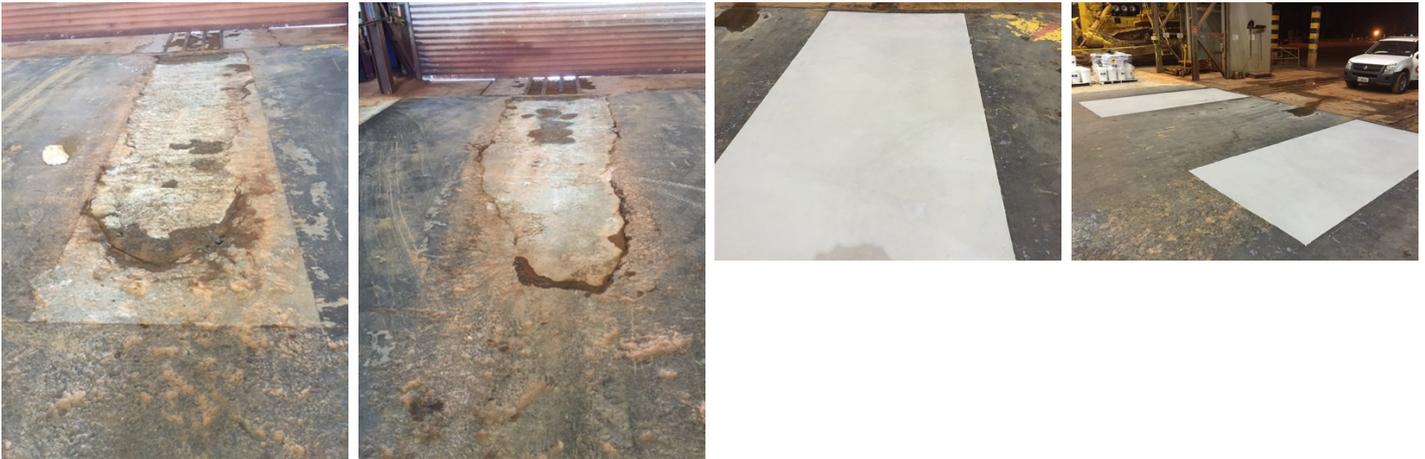
Photograph Descriptions

The workshop floor had been damaged by the caterpillar tracks making 180 degree turns tearing up the concrete.

* 1. The damaged concrete floor 2. Another area of damage 3. Close up of the repaired area 4. View of the workshop showing repairs ,

Application was carried out in accordance with Belzona System Leaflet FPA-1. The floor area was badly damaged and had to be dug out to provide a suitable surface for rebuilding. Once done the area was re-built to the original level using the Belzona 4111 system.

Belzona 4111 was chosen after a successful trial area proved the extremely hard wearing and high load bearing properties of the product. The fast curing nature of the material was also a consideration as it meant the workshop could remain operational during repairs.
