80 TONNE BULLDOZER TRACKS-NO PROBLEM FOR BELZONA

ID: 6296

Customer Location: *Workshop floor, Kwinana, Western Australia*

Application: *FPA-Floor Problem Areas*

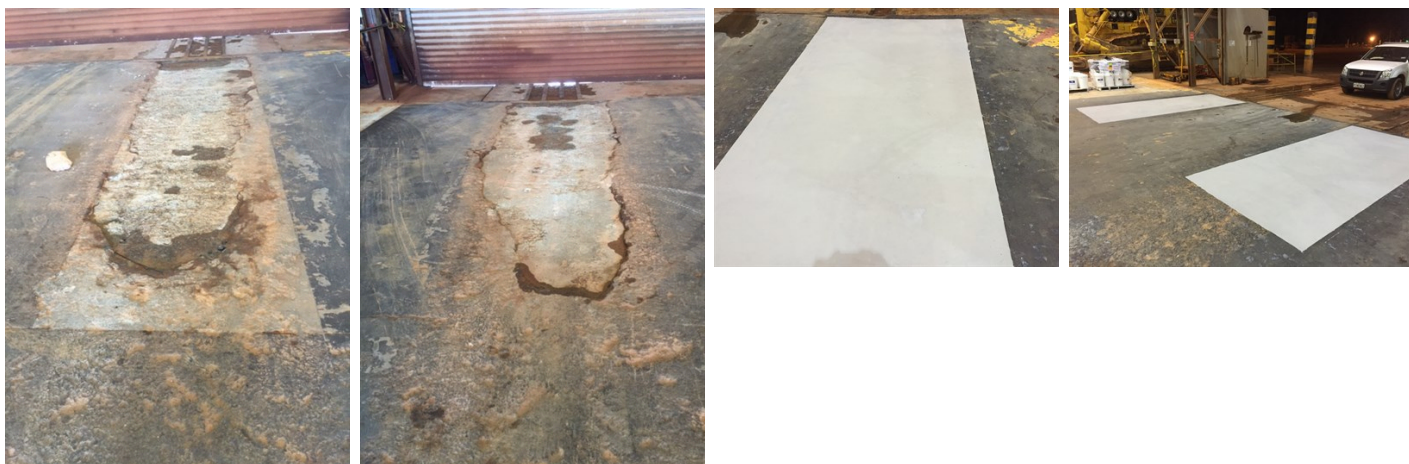
Photograph Descriptions

The workshop floor had been damaged by the caterpillar tracks making 180 degree turns tearing up the concrete.

* 1. The damaged concrete floor 2. Another area of damage 3. Close up of the repaired area 4. View of the workshop showing repairs ,

Application was carried out in accordance with Belzona System Leaflet FPA-1. The floor area was badly damaged and had to be dug out to provide a suitable surface for rebuilding. Once done the area was re-built to the original level using the Belzona 4111 system.

Belzona 4111 was chosen after a successful trial area proved the extremely hard wearing and high load bearing properties of the product. The fast curing nature of the material was also a consideration as it meant the workshop could remain operational during repairs.
