BELZONA SEALS BROKEN SKYLIGHTS

Industry: *Buildings & Structures*
Application: *RPA-Roof Problem Areas*
Substrate: *Bitumen*
Products: ** Belzona 3111 (Flexible Membrane) ,*

Customer Location: *Office building, Bielsko-Biala, Poland*
Application Date: *July 2009*

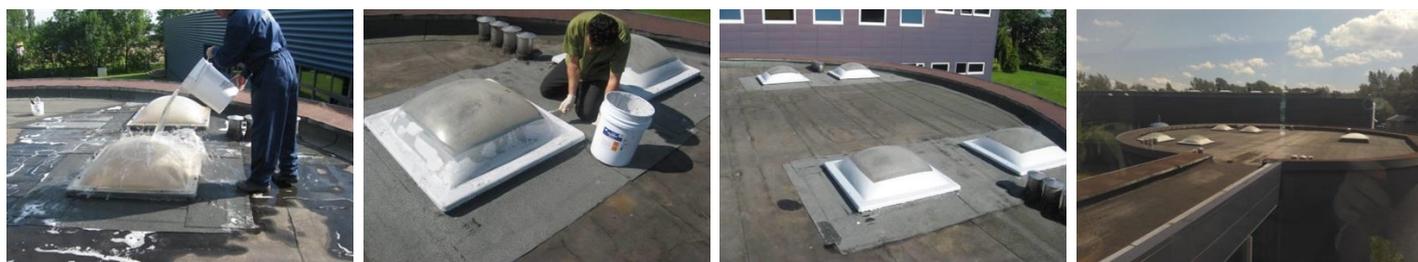
Photograph Descriptions

Under the influence of the sun skylights had broken around the fastening bolts allowing leakage of water into the rooms below whenever it rained.

* 1. Washing damaged skylights 2. Application of Belzona 3111 onto the Belzona 3911 Conditioner 3. Rooftop view immediately after the repair. 4. Rooftop view August 2016 ,

Application was carried out in accordance with Belzona Know-How System Leaflet RPA-3.

Repair cost less than half the purchase and replacement costs of new skylights. Inspected in August 2016 repairs still in excellent condition and keeping offices dry.
