BELZONA REPLACES EXPANSION JOINTS IN OLYMPIC SIZED LAP POOL

ID: 6299

Customer Location: *Ladysmith, BC*

Application Date: *March 2010*

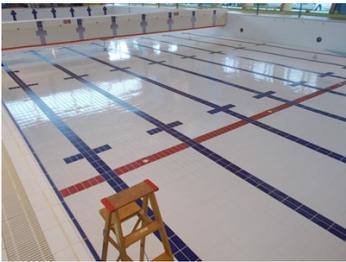
- * 1. Overall view of the size of the facility ,
- * 2. Old flexible jointing material being removed. ,
- * 3. Application of Belzona 2211/2221 ,
- * 4. Completed application after masking tape has been removed. ,

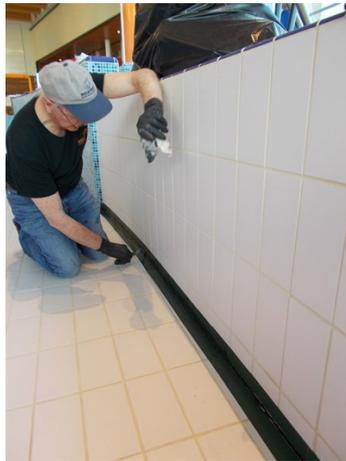
The expansion joints of a pool suffering from chemical attack.

The application was carried out in accordance with a modified version of Belzona Know-How System Leaflet HEX-13b. The old jointing material was completely removed prior to application. Concrete substrate was roughed and cleaned and then Belzona 2211 and 2221 were injected into the joint before being troweled into place.
