# BELZONA PROTECTS A NEW WASTE WATER PUMP AND IMPELLER FROM EROSION

ID: 6308

Customer Location: Toronto, Ontario, Canada  
Application Date: September 2015

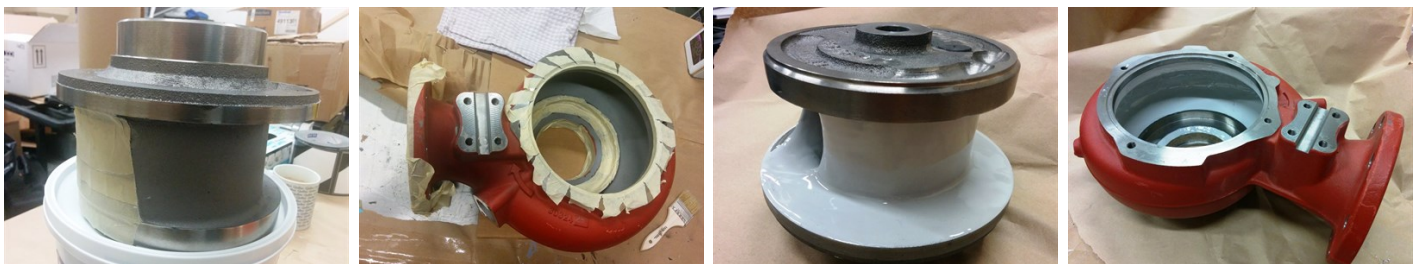
## Photograph Descriptions

- \* 1. Impeller masked and abrasive blasted awaiting coating ,
- \* 2. Volute masked and abrasive blasted awaiting coating ,
- \* 3. Finished application of 1331 on impeller ,
- \* 4. Finished application of 1331 on volute ,

Belzona 1331 applied in accordance with the IFU and following the Belzona Know-How system leaflet CEP-03 for application of internal coatings for centrifugal pumps. The pump volute and impeller were masked off to protect machined surfaces and areas not requiring coating. The surface was then abrasive blasted to the required standard. The Belzona 1331 was applied as a two coat system. The first coat (Grey) was applied by brush at a DFT of 15 mils (375 Microns), followed by a second coat (white) also applied by brush at a DFT of 15 mils (375 microns).
