# Belzona Floor Coating System Protects Commercial Truck Lift Elevator Floor

ID: 6317

**Industry:** Commercial Facilities  
**Application:** FPA-Floor Problem Areas  
**Substrate:** Checker Plate Steel  
**Products:** \* Belzona 5231 (SG Laminate) ,  
\* Belzona 5233 ,  
\* Belzona 9232 (Aggregate) ,

**Customer Location:** Toronto, Ontario, Canada  
**Application Date:** November 21, 2015

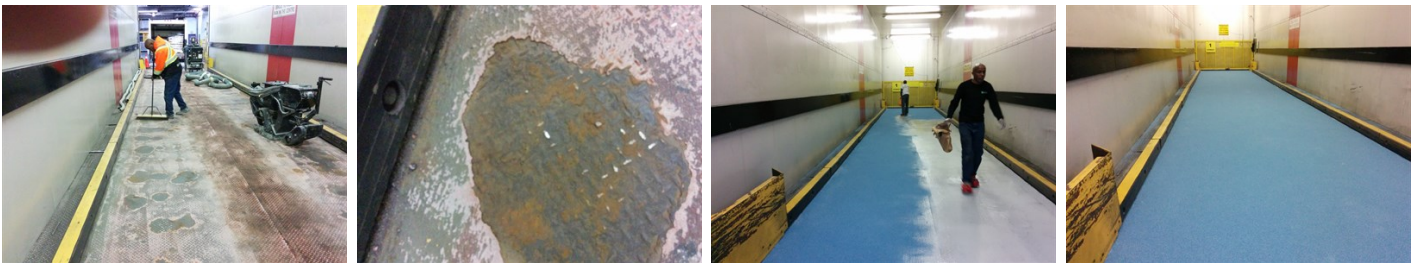
## Photograph Descriptions

Existing screed flooring covering a steel checker plate floor had failed due to a combination of corrosion, chemical attack (Road salt in winter), traffic load and movement. The failing screed had chipped off and was allowing the steel substrate to corrode. There were also concerns over cleanliness and slip & fall safety.

- \* 1. Truck elevator existing screed coating being removed and surface prepared ,
- \* 2. Damaged screed and corroded substrate ,
- \* 3. Belzona 9232 being broadcast into Belzona 5231 ,
- \* 4. Completed application with Belzona 5233 top coat ,

Belzona 5231, 9232 and 5233 were all applied in accordance with the Belzona 5233 IFU and following the Belzona know-How system leaflet FPA-08 application of non-slip safety surfaces for floors. The substrate was abrasive blasted to the required standard, removing the failed screed material. The Belzona 5231 was applied by roller at a DFT of 10 mils (250 Microns), whilst wet Belzona 9232 was broadcast to rejection into the Belzona 5231. Once cured the excess Belzona 9232 was swept and vacuumed away and the top coat of Belzona 5233 applied by roller.
