Belzona Rebuilds a Damaged Bearing Housing

ID: 6321

Industry: *General Industry*
Application: *MPT-Mechanical Power Transmission*

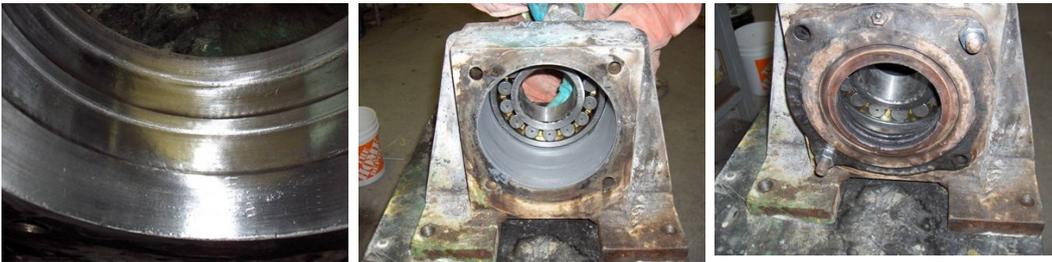
Photograph Descriptions

Bearing had seized due to the lack of lubrication. This caused it to spin loose and erode away the metal on the bottom of the housing

- * The bearing housing had worn oversize because of lacking of lubrication. The eroded area was prepared by using a Bristle Blaster ,
- * The worn area was rebuilt with a thin layer of Belzona 1111 ,
- * A new housing was pressed into place and the Belzona material allowed to set up before the component was reinstalled. ,

The application was carried out in accordance with Belzona Know-How System Leaflet MPT-7. The damaged areas were cleaned using a bristle blaster. Then the repair areas were rebuilt with Belzona 1111. A new housing were inserted into place.

Rebuilding the housing in this manner allowed the plant to use the existing housing and stock bearing, eliminating the need to machine the housing to oversize the procure a new bearing set.
