# Belzona Rebuilds a Damaged Bearing Housing

ID: 6321

Industry: *General Industry*  
Application: *MPT-Mechanical Power Transmission*

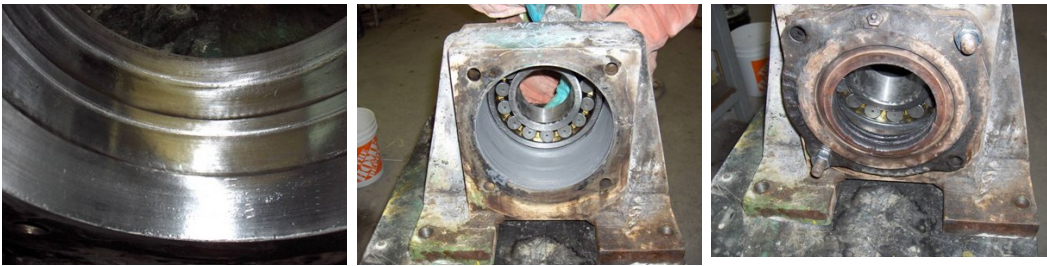
*Bearing had seized due to the lack of lubrication. This caused it to spin loose and erode away the metal on the bottom of the housing*

- \* The bearing housing had worn oversize because of lacking of lubrication. The eroded area was prepared by using a Bristle Blaster ,
- \* The worn area was rebuilt with a thin layer of Belzona 1111 ,
- \* A new housing was pressed into place and the Belzona material allowed to set up before the component was reinstalled. ,

The application was carried out in accordance with Belzona Know-How System Leaflet MPT-7. The damaged areas were cleaned using a bristle blaster. Then the repair areas were rebuilt with Belzona 1111. A new housing were inserted into place.

Rebuilding the housing in this manner allowed the plant to use the existing housing and stock bearing, eliminating the need to machine the housing to oversize the procure a new bearing set.
