# Belzona Spruces Up Steps at a Condominium and Protects from UV

**Industry:** Buildings & Structures  
**Application:** FPA-Floor Problem Areas  
**Substrate:** Concrete  
**Products:** \* Belzona 4131 (Magma Screed) ,  
\* Belzona 4411 (Granogrip) ,  
\* Belzona 4911 (TX Conditioner) ,  
\* Belzona 5231 (SG Laminate) ,  
\* Belzona 5233 ,

**Customer Location:** Toronto, Ontario, Canada  
**Application Date:** July 9th, 2015

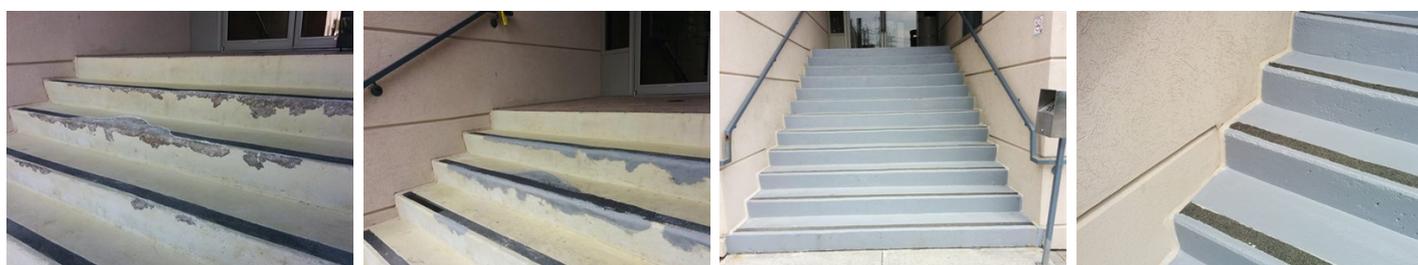
The existing coating that was applied was not UV resistant and had changed color (yellowed) due to exposure from ultra violet light. Additionally removal of ice build up with a shovel had damaged the coating allowing corrosion of the concrete substrate.

- \* 1. Damaged steps ,
- \* 2. Damage repaired with Belzona 4131 ,
- \* 3. Application of Belzona 5231 and 4411 ,
- \* 4. Completed application of Belzona 5233 and contrasting 4411 grip system. ,

The application was completed by following Belzona Know How System Leaflets FPA-01 and FPA-08. Preparation of the concrete and existing coating was completed by pressure washing and removing any loose, flaking concrete and coating. The surface was abraded to ensure optimum adhesion. The localized damage was repaired using Belzona 4911 and Belzona 4131. A base coat of Belzona 5231 (with Aggregate) in light grey color was applied to all surfaces. Application of a step edge grip system was completed to current code using Belzona 4411 and Belzona 9211 to provide safety and visual contrast. A final coating of Belzona 5233 was then applied to provide aesthetically pleasing finish and UV resistance.
