Belzona Coats Submersible Pump for Potable Water

Customer Location: Filtration Plant, Montréal, Québec, Canada

Application: CEP-Centrifugal Pumps

Application Date: July 2016

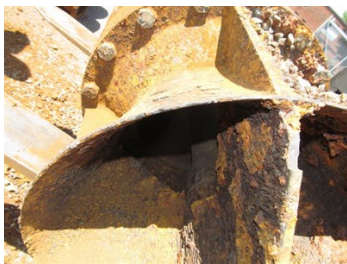
Corroded suction bell needed repair

Suction bell rebuilt with Belzona 1111 and overcoat with Belzona 5812DW

Belzona surface preparation respected. 3 mils roughness profile. Aluminium oxide angular abrasive was used for blasting. Belzona system leaflets, CEP-3, 4, 6, was followed.

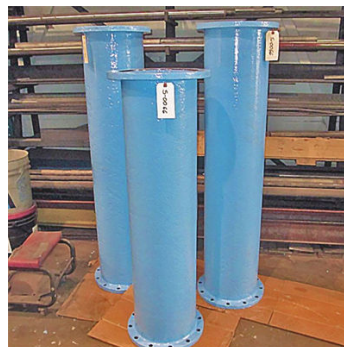
Other pump parts coated inside out with Belzona 5812DW
