BELZONA 7111 ALIGNS NEW INDUSTRIAL EQUIPMENT

ID: 6329

Customer Location: *Manufacturing Plant, FL, USA*
Application Date: *August 2016*

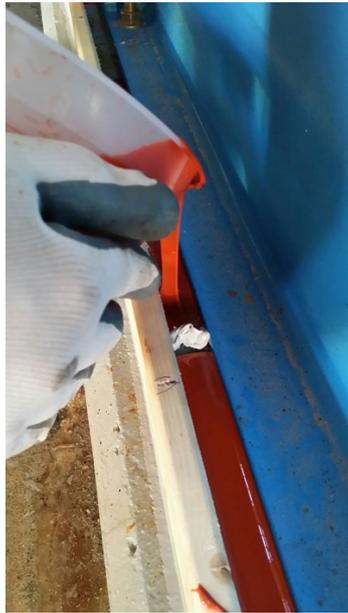
- * 1. View of the gap needed to be filled. ,
- * 2. Temporary wood dam and expansion joint. ,
- * 3. Pouring of first layer. ,
- * 4. After dam removal. ,
